report group: Playground Inspection
title: 7003 Falling Water Dr. Spring, Tx 77379
created: 12/20/22, 11:20 AM
modified: 12/21/22, 9:57 AM
item count: 21

Scope of the playground safety inspection:
the play equipment was inspected against the current CPSC public playground Safety Handbook and ASTM F1487-17. Any equipment that was not in compliance will be reported in this inspection report and the standard will be cited. Any items that the inspector found to be in compliance but that may need to be monitored will also be noted.

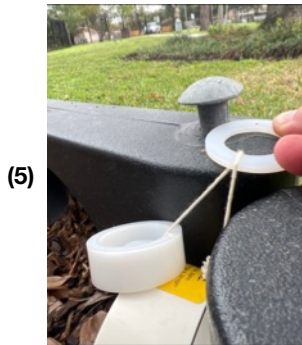
created: 12/20/22, 11:51 AM
modified: 12/20/22, 11:51 AM
taken by app: Yes
description: Impalement/entanglement/tripping hazard

[ASTM F1487 6.4](#)

-there shall be no entanglement hazards on public play equipment.

[CPSC 3.6 Tripping Hazard](#)

-play areas should be free of tripping hazards to children who are using a playground. two common causes of tripping are anchoring devices for playground equipment and containment walls for loose fill surfacing materials.

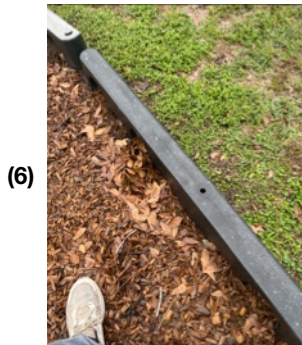
created: 12/20/22, 11:52 AM
modified: 12/20/22, 11:52 AM
taken by app: Yes
description: Missing border anchor

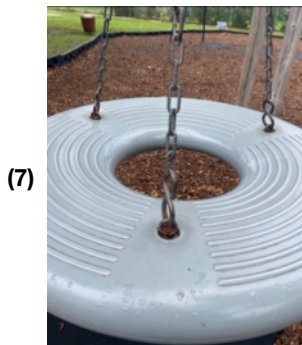
created: 12/20/22, 11:54 AM
modified: 12/20/22, 11:54 AM
taken by app: Yes
description: SHooks in good shape
Rusted slightly- should monitor and replace if worsens

[ASTM F 1487 6.4.5 Connecting Device](#)

-connection device such as, but not limited to, S-hooks and C-hooks, when properly closed, are not entanglement hazards. these connectors are considered closed when there is no gap greater than .04 inches.

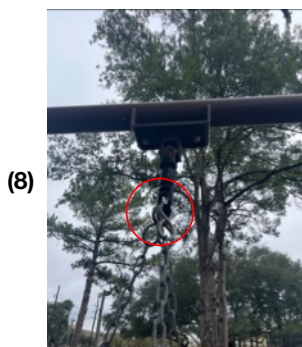
[ASTM F 1487 6.4.5 Connecting Device](#)

-connection device such as, but not limited to, S-hooks and C-hooks, when properly closed, are not entanglement hazards. these connectors are considered closed when there is no gap greater than .04 inches.

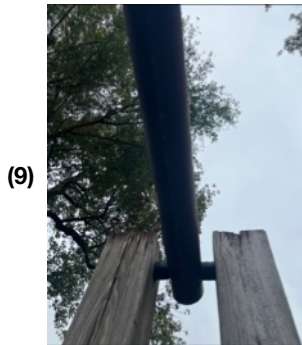
ASTM F1487 4.1.1

-Metals subject to structural degradation such as rust or corrosions shall be painted, galvanized, or otherwise treated.

CPSC 2.5.4

-Paint and other finishes should be maintained to prevent rusting of exposed metals and to minimize children playing with peeling paint and paint flakes.

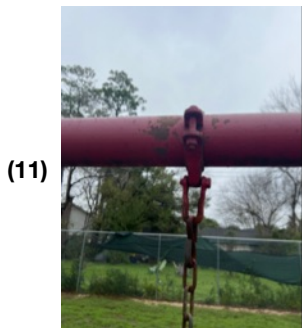
created: 12/20/22, 11:56 AM
modified: 12/20/22, 11:56 AM
taken by app: Yes
description: Rust/paint chips and flaking

ASTM F1487 4.1.1

-Metals subject to structural degradation such as rust or corrosions shall be painted, galvanized, or otherwise treated.

CPSC 2.5.4

-Paint and other finishes should be maintained to prevent rusting of exposed metals and to minimize children playing with peeling paint and paint flakes.

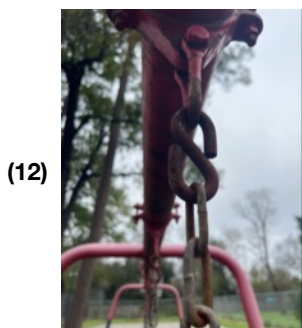
created: 12/20/22, 11:57 AM
modified: 12/21/22, 9:57 AM
taken by app: Yes
description: S-hook non-compliant
Paint chips/rust

ASTM F1487 4.1.1

-Metals subject to structural degradation such as rust or corrosions shall be painted, galvanized, or otherwise treated.

CPSC 2.5.4

-Paint and other finishes should be maintained to prevent rusting of exposed metals and to minimize children playing with peeling paint and paint flakes.

ASTM F1487 6.4.5.1

-No portion of the closed end of an S-hook lower loop may project beyond the vertical boundary established by the upper loop.

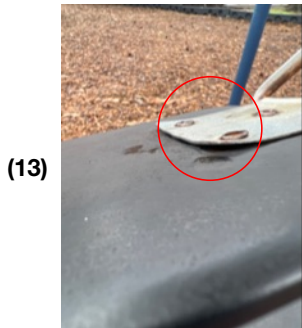
CPSC 3.4

- Exposed open ends of all tubing not resting on the ground or otherwise covered should be covered by caps or plugs.
- Wood Parts should be smooth and free from splinters
- All corners, metal and wood, should be rounded
- All metal edges should be rolled or have rounded capping
- Prevent injuries caused by splintered wood, sharp points, corners, or edges that may develop as a result of wear and tear on equipment.

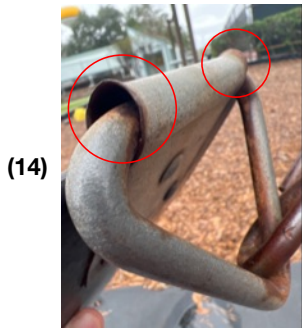
created: 12/20/22, 11:58 AM
modified: 12/21/22, 9:56 AM
taken by app: Yes
description: Worn bushing on swing

CPSC 3.4

- Exposed open ends of all tubing not resting on the ground or otherwise covered should be covered by caps or plugs.
- Wood Parts should be smooth and free from splinters
- All corners, metal and wood, should be rounded
- All metal edges should be rolled or have rounded capping
- Prevent injuries caused by splintered wood, sharp points, corners, or edges that may develop as a result of wear and tear on equipment.

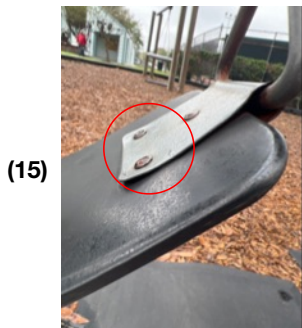
created: 12/20/22, 11:59 AM
modified: 12/21/22, 9:56 AM
taken by app: Yes
description: Worn busing, replace swing X 2

CPSC 3.4

- Exposed open ends of all tubing not resting on the ground or otherwise covered should be covered by caps or plugs.
- Wood Parts should be smooth and free from splinters
- All corners, metal and wood, should be rounded
- All metal edges should be rolled or have rounded capping
- Prevent injuries caused by splintered wood, sharp points, corners, or edges that may develop as a result of wear and tear on equipment.

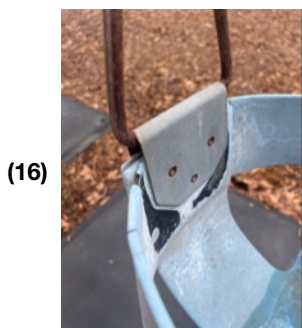
created: 12/20/22, 12:00 PM
modified: 12/20/22, 12:00 PM
taken by app: Yes
description: Cracked and worn bucket swings X 2

CPSC 3.4

- Exposed open ends of all tubing not resting on the ground or otherwise covered should be covered by caps or plugs.
- Wood Parts should be smooth and free from splinters
- All corners, metal and wood, should be rounded
- All metal edges should be rolled or have rounded capping
- Prevent injuries caused by splintered wood, sharp points, corners, or edges that may develop as a result of wear and tear on equipment.

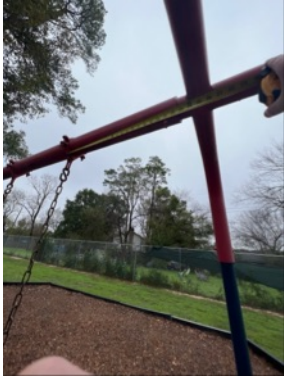
(17)

created: 12/20/22, 12:03 PM
modified: 12/20/22, 12:03 PM
taken by app: Yes
description: Swing chain must be minimum 30"
from side support
- needs to be moved inward

[ASTM F1487 8.6.5.1.3](#)

-The horizontal distance between the supporting structure and the adjacent suspension elements or suspended elements, whichever is closer, shall be no less than 30 inches

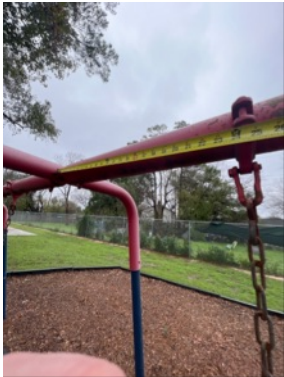
(18)

created: 12/20/22, 12:03 PM
modified: 12/20/22, 12:03 PM
taken by app: Yes
description: Swing chain must be minimum 30"
from side support
- needs to be moved inward

[ASTM F1487 8.6.5.1.3](#)

-The horizontal distance between the supporting structure and the adjacent suspension elements or suspended elements, whichever is closer, shall be no less than 30 inches.

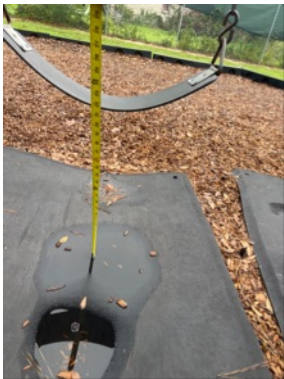
(19)

created: 12/20/22, 12:04 PM
modified: 12/20/22, 12:04 PM
taken by app: Yes
description: Raise level of loose fill surfacing so
that swing is 12" from surface.

[CPSC 4.3 Loose-Fill Surfacing](#)

-loose fill surfacing materials require special maintenance, this can be facilitated by marking ideal surfacing depth on equipment post.

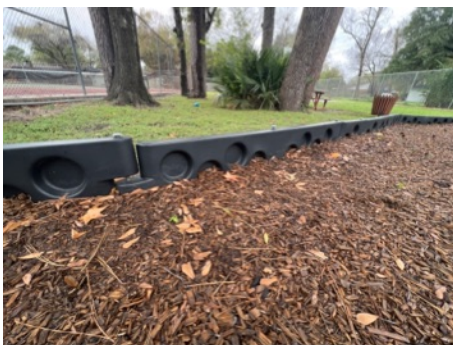
(20)

[ASTM F1487 6.4](#)

-there shall be no entanglement hazards on public play equipment.

[CPSC 3.6 Tripping Hazard](#)

-play areas should be free of tripping hazards to children who are using a playground. two common causes of tripping are anchoring devices for playground equipment and containment walls for loose fill surfacing materials.
