report group: Playground Inspection  
title: 17902 Hawk Haven Ln.  
created: 12/20/22, 9:59 AM  
modified: 12/21/22, 10:26 AM  
item count: 29

Scope of the playground safety inspection:  
the play equipment was inspected against the current CPSC public playground Safety Handbook and ASTM F1487-17. Any equipment that was not in compliance will be reported in this inspection report and the standard will be cited. Any items that the inspector found to be in compliance but that may need to be monitored will also be noted.

report group: Compliant Park Inspection  
title: 17902 Hawk Haven Ln.  
created: 3/10/23, 9:25 AM  
modified: 3/21/23, 7:04 AM  
item count: 17

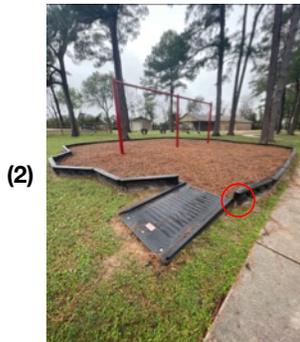
created: 12/20/22, 10:03 AM  
modified: 12/21/22, 9:53 AM  
taken by app: Yes  
description: Swing area

ASTM F1487 6.2 Sharp Points and Sharp Edges  
-there shall be no accessible sharp points or edges on public play equipment

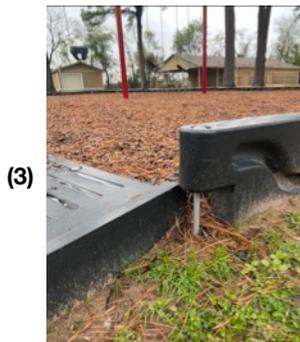
created: 12/20/22, 10:03 AM  
modified: 12/20/22, 10:03 AM  
taken by app: Yes  
description: Ground level entanglement hazard

ASTM F1487 6.4  
-there shall be no entanglement hazards on public play equipment.

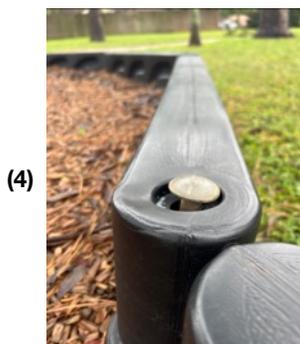
created: 12/20/22, 10:05 AM  
modified: 12/20/22, 10:05 AM  
taken by app: Yes  
description: Entanglement/tripping hazard

ASTM F1487 6.4  
-there shall be no entanglement hazards on public play equipment.  
CPSC 3.6 Tripping Hazard  
-play areas should be free of tripping hazards to children who are using a playground. two common causes of tripping are anchoring devices for playground equipment and containment walls for loose fill surfacing materials.

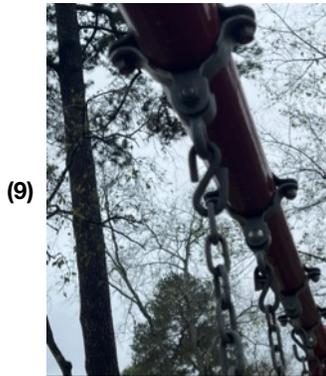
ASTM F 1487 6.4.5 Connecting Device  
-connection device such as, but not limited to, S-hooks and C-hooks, when properly closed, are not entanglement hazards. these connectors are considered closed when there is no gap greater than .04 inches.

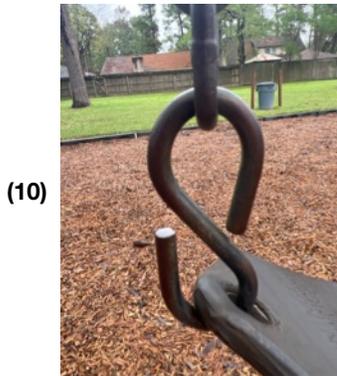
created: 12/20/22, 10:16 AM  
modified: 12/20/22, 10:16 AM  
taken by app: Yes  
description: Gap greater than .04 in s-hook

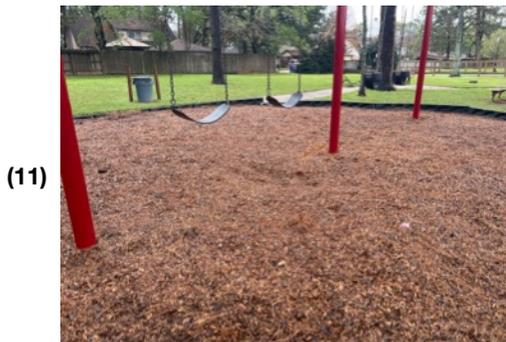
created: 12/20/22, 10:19 AM  
modified: 12/20/22, 10:19 AM  
taken by app: Yes  
description: Plenty of loose fill surface material.  
Need swings lowered, rake loose fill so evenly dispersed.

CPSC 4.3 loose-fill surfacing  
-areas under swings and at slide exits. Activity tends to displace surfacing quickly. rake loose-fill back into place.

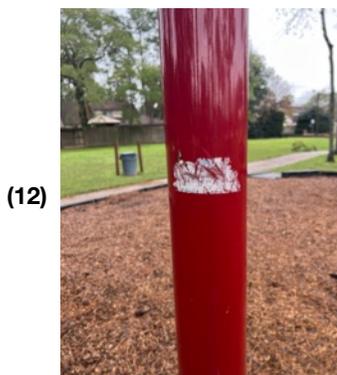
created: 12/20/22, 10:21 AM  
modified: 12/20/22, 10:21 AM  
taken by app: Yes  
description: Missing signage  
-manufacturer  
- age appropriateness  
-supervision

ASTM F1487 14.1  
-Posting of signs and/or labels shall be the responsibility of the owner/operator of the play equipment. the information regarding the intended ages of users shall be provided by the manufacturer.

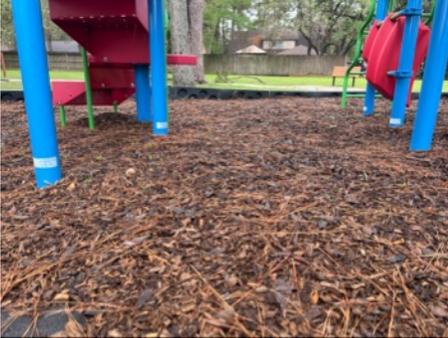
(13)

created: 12/20/22, 10:23 AM  
modified: 12/20/22, 10:23 AM  
taken by app: Yes  
description: Loose fill material needed

[CPSC 4.3 Loose-Fill Surfacing](#)

-loose fill surfacing materials require special maintenance, this can be facilitated by marking ideal surfacing depth on equipment post.

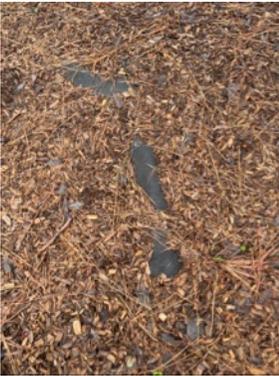
(14)

created: 12/20/22, 10:24 AM  
modified: 12/20/22, 10:24 AM  
taken by app: Yes  
description: Weed barrier showing  
-add loose fill

[CPSC 4.3 Loose-Fill Surfacing](#)

-loose fill surfacing materials require special maintenance, this can be facilitated by marking ideal surfacing depth on equipment post.

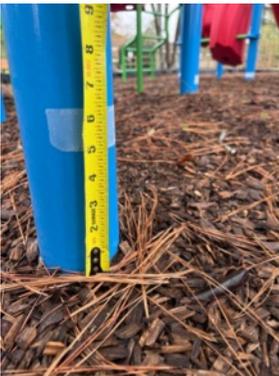
(15)

created: 12/20/22, 10:32 AM  
modified: 12/20/22, 10:32 AM  
taken by app: Yes  
description: Loose fill surfacing needed

[CPSC 4.3 Loose-Fill Surfacing](#)

-loose fill surfacing materials require special maintenance, this can be facilitated by marking ideal surfacing depth on equipment post.

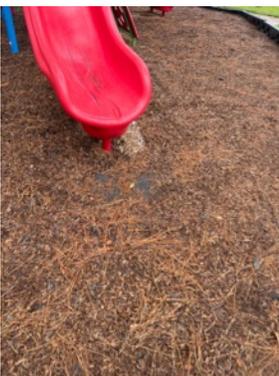
(16)

created: 12/20/22, 10:32 AM  
modified: 12/20/22, 10:32 AM  
taken by app: Yes  
description: Bare surface area at slide exit

[CPSC 4.3 Loose-Fill Surfacing](#)

-loose fill surfacing materials require special maintenance, this can be facilitated by marking ideal surfacing depth on equipment post.

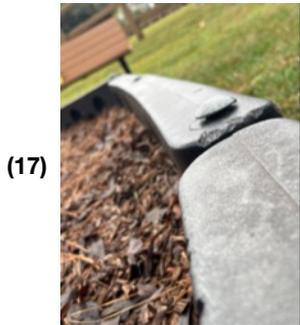
created: 12/20/22, 10:35 AM  
modified: 12/20/22, 10:35 AM  
taken by app: Yes  
description: Tripping/entanglement hazard  
along playground border  
- at least 20+ locations of this  
problem

[CPSC 3.6 Tripping Hazard](#)

-play areas should be free of tripping hazards to children who are using a playground. two common causes of tripping are anchoring devices for playground equipment and containment walls for loose fill surfacing materials

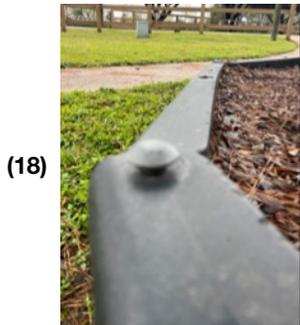
created: 12/20/22, 10:36 AM  
modified: 12/20/22, 10:36 AM  
taken by app: Yes  
description: Trip/entanglement hazard

[CPSC 3.6 Tripping Hazard](#)

-play areas should be free of tripping hazards to children who are using a playground. two common causes of tripping are anchoring devices for playground equipment and containment walls for loose fill surfacing materials

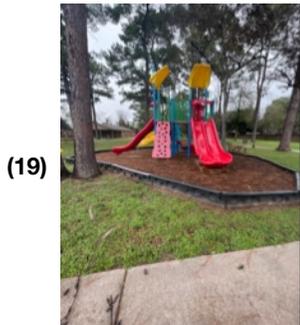
created: 12/20/22, 10:39 AM  
modified: 12/20/22, 10:39 AM  
taken by app: Yes  
description: No signage anywhere around  
playground nor on the equipment  
of playground

[ASTM F1487 14.1](#)

-Posting of signs and/or labels shall be the responsibility of the owner/operator of the play equipment. the information regarding the intended ages of users shall be provided by the manufacturer, designer, or consultant.

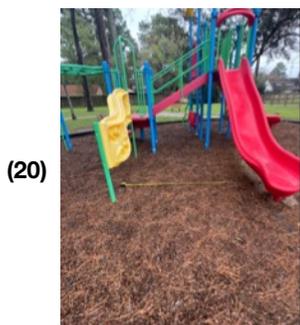
created: 12/20/22, 10:45 AM  
modified: 12/21/22, 10:26 AM  
taken by app: Yes  
description: Use zone overlapping where not  
permitted

[ASTM F1487 9.8.1](#)

-Sufficient space shall be provided between all adjacent structures and individual play equipment for the purposes of play and circulation.

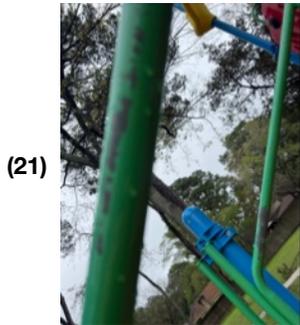
created: 12/20/22, 10:46 AM  
modified: 12/20/22, 10:46 AM  
taken by app: Yes  
description: Paint flakes, chips

CPSC 2.5.4

-Paint and other finishes should be maintained to prevent rusting of exposed metals and to minimize children playing with peeling paint and paint flakes.

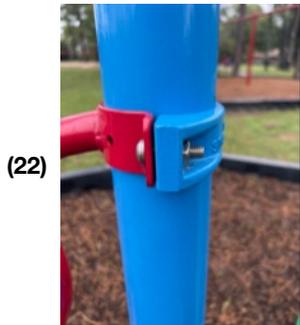
created: 12/20/22, 10:47 AM  
modified: 12/20/22, 10:47 AM  
taken by app: Yes  
description: No more than 2 threads shall be showing

ASTM F1487 - 6.4.3

-accessible bolt end projecting beyond the face of the nut more than two full threads is an entanglement hazard.

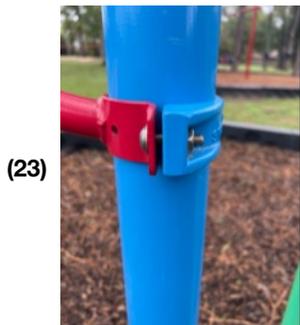
created: 12/20/22, 10:48 AM  
modified: 12/20/22, 10:48 AM  
taken by app: Yes  
description: No more than 2 threads showing

ASTM F1487 - 6.4.3

-accessible bolt end projecting beyond the face of the nut more than two full threads is an entanglement hazard.

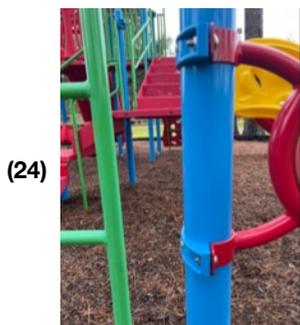
created: 12/20/22, 10:48 AM  
modified: 12/20/22, 10:48 AM  
taken by app: Yes  
description: Top non compliant  
Bottom compliant

ASTM F1487 - 6.4.3

-accessible bolt end projecting beyond the face of the nut more than two full threads is an entanglement hazard.

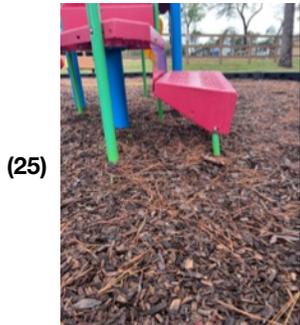
created: 12/20/22, 10:52 AM  
modified: 12/20/22, 10:52 AM  
taken by app: Yes  
description: Main entry/staircase unstable, broke MUST be addressed asap

[ASTM F1487 7.1.1](#)

-accessible routes within a use zone shall conform to the performance requirements of specifications F1292 and F1951.

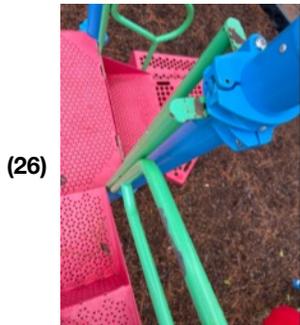
created: 12/20/22, 10:54 AM  
modified: 12/20/22, 10:54 AM  
taken by app: Yes  
description: Paint flaking/chipping

[CPSC 2.5.4](#)

-Paint and other finishes should be maintained to prevent rusting of exposed metals and to minimize children playing with peeling paint and paint flakes.

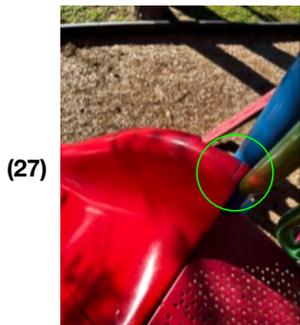
created: 12/21/22, 10:12 AM  
modified: 12/21/22, 10:20 AM  
taken by app: No  
description: Crack in slide side wall.

[ASTM F1487 8.5.1](#)

-Accesses to slides shall meet the same requirements as those for playground equipment in general, as specified in section 7

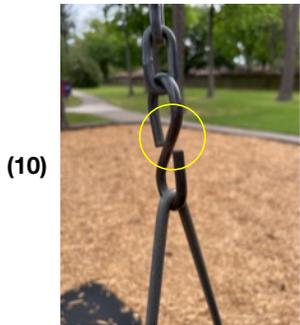
created: 3/20/23, 9:52 AM  
modified: 3/21/23, 6:54 AM  
taken by app: Yes  
description: S-hook upper loop aligns with body and is >.04 inches.

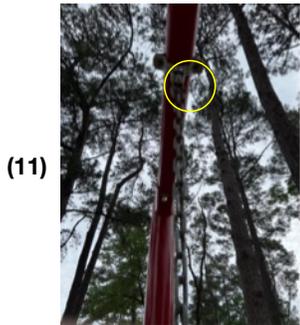
created: 3/20/23, 9:53 AM  
modified: 3/21/23, 6:57 AM  
taken by app: Yes  
description: Upper loop overlaps body, passing loop projection test.
