report group: Playground Inspection
title: 7003 Falling Water Dr. Spring, Tx 77379
created: 12/20/22, 11:20 AM
modified: 12/21/22, 9:57 AM
item count: 21

Scope of the playground safety inspection:
the play equipment was inspected against the current CPSC public playground Safety Handbook and ASTM F1487-17. Any equipment that was not in compliance will be reported in this inspection report and the standard will be cited. Any items that the inspector found to be in compliance but that may need to be monitored will also be noted.

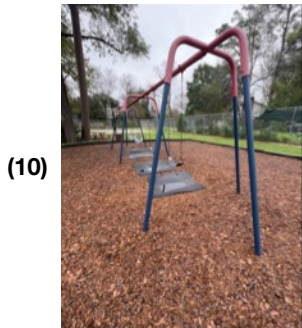
-Metals subject to structural degradation such as rust or corrosions shall be painted, galvanized, or otherwise treated.

CPSC 2.5.4

-Paint and other finishes should be maintained to prevent rusting of exposed metals and to minimize children playing with peeling paint and paint flakes.
