report group: Playground Inspection  
title: 17902 Hawk Haven Ln.  
created: 12/20/22, 9:59 AM  
modified: 12/21/22, 10:26 AM  
item count: 29

Scope of the playground safety inspection:  
the play equipment was inspected against the current CPSC public playground Safety Handbook and ASTM F1487-17. Any equipment that was not in compliance will be reported in this inspection report and the standard will be cited. Any items that the inspector found to be in compliance but that may need to be monitored will also be noted.

report group: Compliant Park Inspection  
title: 17902 Hawk Haven Ln.  
created: 3/10/23, 9:25 AM  
modified: 3/21/23, 7:04 AM  
item count: 17

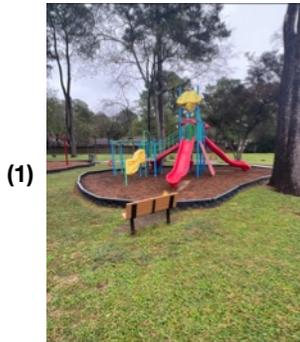
created: 12/20/22, 10:02 AM  
modified: 12/20/22, 10:29 AM  
taken by app: Yes  
description: Playground  
36' diameter  
18' radius

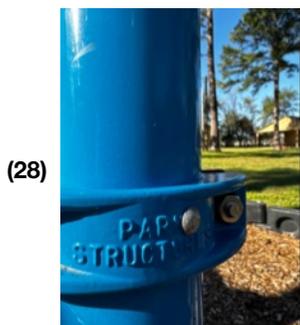
created: 12/21/22, 10:12 AM  
modified: 12/21/22, 10:19 AM  
taken by app: No  
description: Manufacturer of equipment
